Updating the PicoPak Clock Measurement Module Firmware

W.J. Riley
Hamilton Technical Services
Beaufort, SC 29907 USA

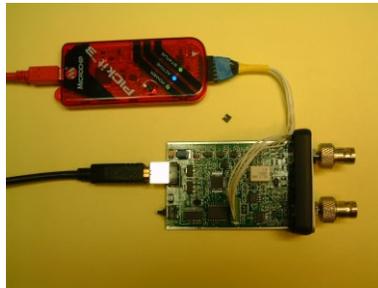
A photograph of the PicoPak firmware programming setup is shown below:

1. PicoPak module to be updated.
2. Windows® PC, XP or later.
3. Microchip .hex file with the new firmware (plus any readme or other notes).
4. Microchip PICkit3 programmer.
5. PicoPak programming cable.
6. Two A/B USB cables.
7. Microchip MPLAB-X IDE program.
8. TeraTerm or other ASCII terminal program.
9. Medium size Phillips screwdriver.
10. Tweezers (optional).

The programming cable uses the standard pinout arrangement as described in the PICkit3 documentation except for a 1x6 2mm (rather than 0.1") female connector that plugs into a mating connector on the PicoPak board. A set of individual M-F jumper wires could also be used.
